Intel[®] Mobile Pentium[®] II Processor Specification Update

Release Date: October 2000

Order Number: 243887-025

The Mobile Pentium[®] II processor may contain design defects or errors known as errata which may cause the product to deviate from published specifications. Current characterized errata are documented in this Specification Update.

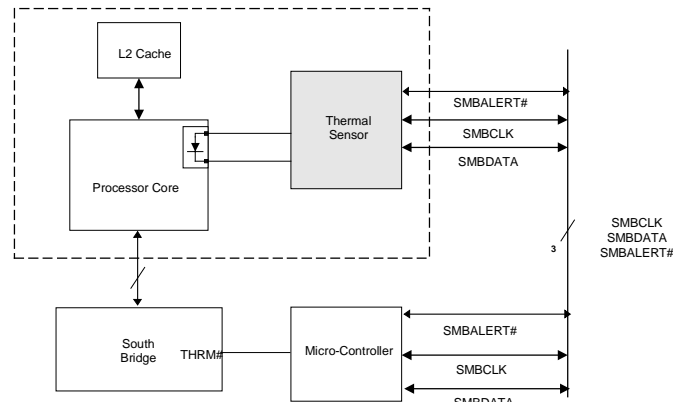
Figure 1. An Example of Microcontroller Driven Thermal Management

B30. Thermal Sensor May Assert SMBALERT# Incorrectly

Problem: The Mobile Pentium II processor and the Pentium II Processor Mobile Module have a thermal sensor that monitors the processor core's temperature. Please note that desktop systems could have a similar thermal device. The thermal sensor asserts SMBALERT# if the processor temperature exceeds the temperature limits set in the Alarm Threshold Registers (T_{HIGH} , T_{LOW}). It also sets the corresponding Status Register bits to identify the cause of the interrupt. Figure 1 gives one example of the how the SMBALERT# signal could be used in a system.

Under the conditions described below, the thermal sensor incorrectly generates the SMBALERT# interrupt. All of the following conditions must be met to trigger a false interrupt:

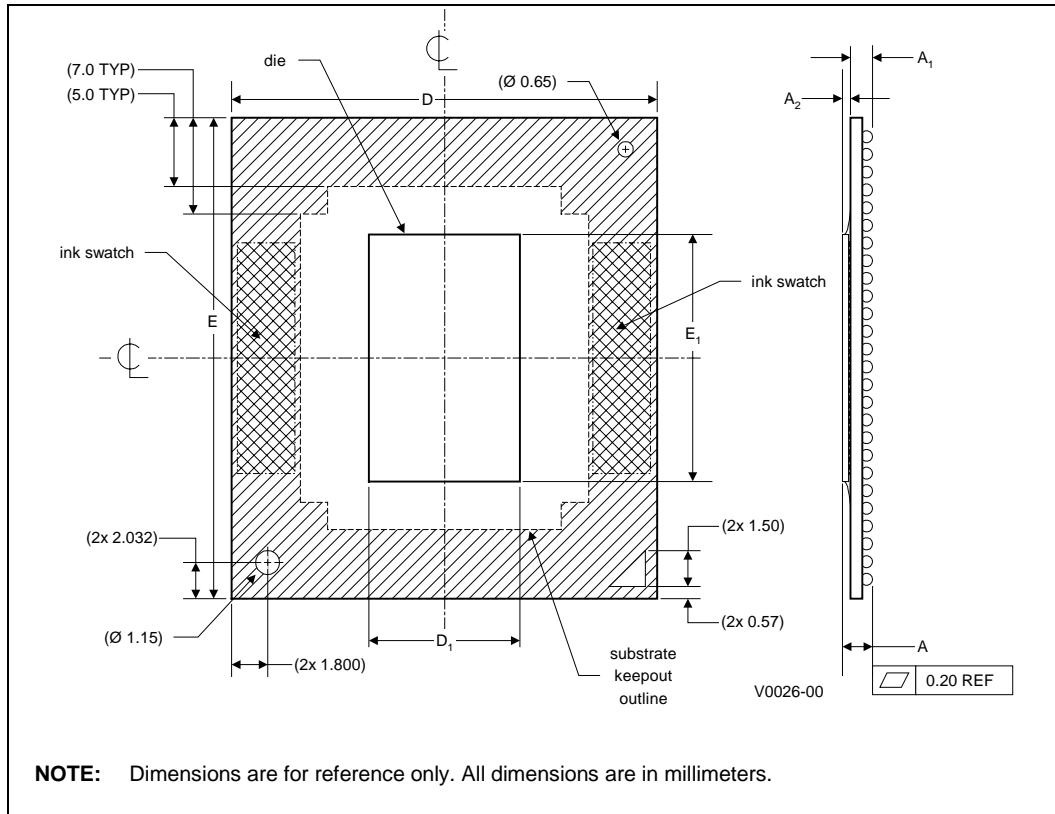
Figure 5.3. Surface-Mount BGA1 Package—Top and Side View

The following table and figures show the updated mechanical specifications for the BGA1 package, listed as Table 5.2, Figure 5.3 and Figure 5.4, respectively, in the *Mobile Pentium® II Processor in BGA Package at 366 MHz, 333 MHz, 300PE MHz, and 266PE MHz* datasheet.

1. The number shown here is different from that in the 243887-010 revision of this specification update. The maximum reference number is used.

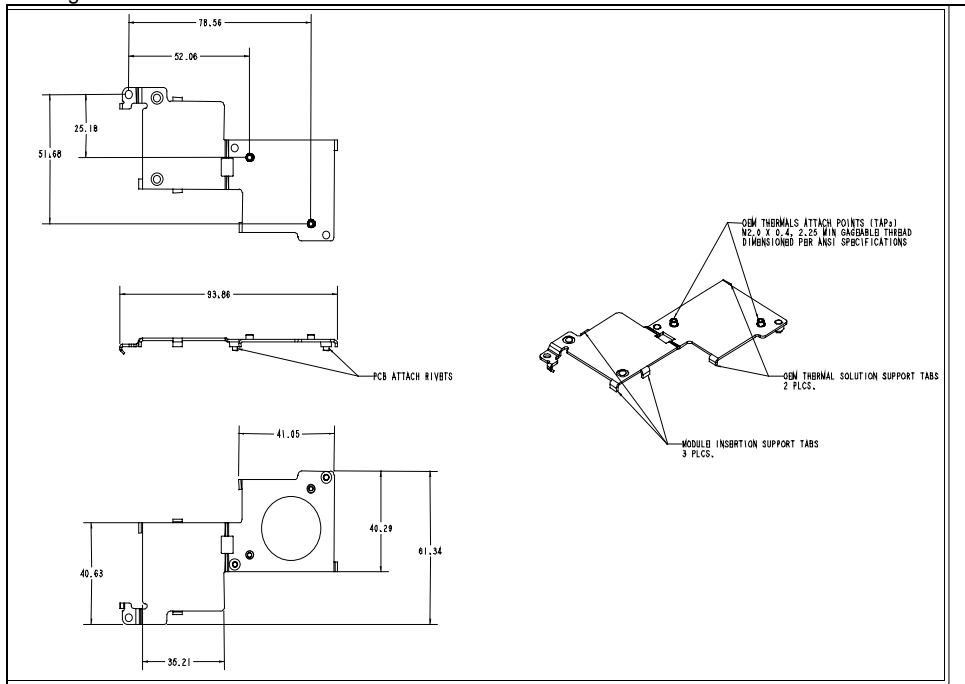
Figure 1. TAP Gageable Thread Clarification

OEM Thermal Attach Points (TAPs) M2.0 x 0.4, 2.25 min gageable thread dimensioned per ANSI specification.

See Figure 1 below for more information.
